05/09/76 Imperial Iranian Air Force (IIAF)

Official Accident Report Index Page

Report Number	NTSS-AAR-78-12
Report Title	Investigation Report--Wing Failure of Boeing 747-131, Near Madrid, Spain, May 9, 1976
Report Date	October 6, 1978
Organization Name	National Transportation Safety Board Bureau of Technology Washington, D. C. 20594
WUN	2479
Sponsor Name	NATIONAL TRANSPORTATION SAFETY BOARD Washington, D. C. 20594
Report Type	Special Investigation Report May 9, 1976
Distribution Status	This document is available to the public through the National Technical Information Service, Springfield, Virginia 22151
Report Class	UNCLASSIFIED
Pg Class	UNCLASSIFIED
Pages	43
Price	H03.A01
Keywords	Aircraft accident; lightning strike; explosion; fuel flammability; wing failure; gust overload; fuel ignition.
Abstract	On May 9, 1976, an Imperial Iranian Air Force Boeing 747-131 crashed as it approached Madrid, Spain. Witnesses observed lightning strike the aircraft followed by fire, explosion, and separation of the left wing. The report includes fire pattern studies, structural failure descriptions, trajectory analysis, fuel flammability calculations, gust loading analysis, and an analytical treat

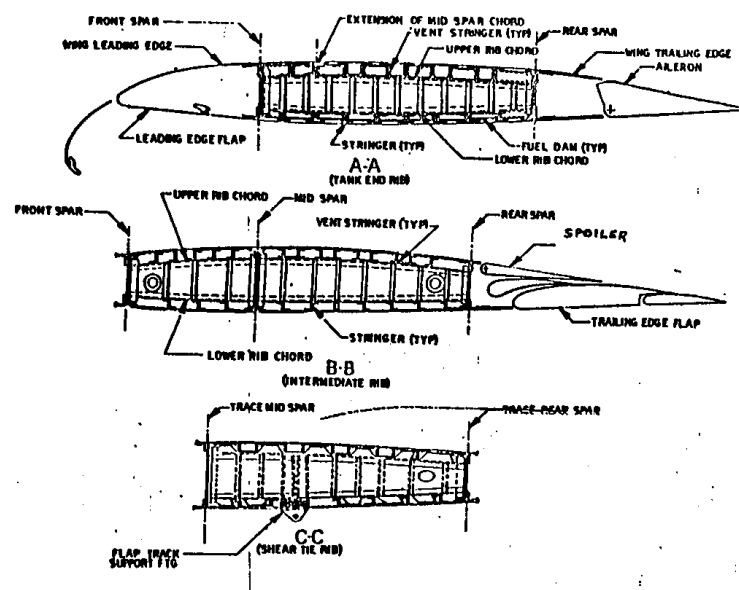
MAJOR WING STRUCTURE

Pitting and localized burn areas typical of lightning attachment damage were found on the left wingtip and on the vertical fin at the VOR antenna. The left wing had separated into 15 major pieces before ground impact and parts of it were found at each location of wreckage. (See drawing on page 31.)

The left wing outboard of the No. 1 engine position separated in three major pieces and along three lines of fracture. The left wingtip, a piece about 20 ft long, separated on a line parallel to the fuselage centerline and roughly halfway between the end of the wing and the No. 1 engine. A second line of separation was just outboard of the No. 1 engine and ran parallel to the rib centerlines. The third line of separation spanned between the first two and ran along the front spar. The wingtip, consisting of the high frequency antenna and coupler, also separated from the wing.
